U.S. CONSUMER PRODUCT SAFETY COMMISSION
4330 EAST WEST HIGHWAY
BETHESDA, MD 20814

March 24, 2015

1. Task Number 131022HCC1048		2. Investigator's ID 9075		EPIDEMIOLOGIC INVESTIGATION REPORT
3. Office Code 810	4. Date of Accident YR MO DAY 2012 03 09	5. Date Initiated YR MO DAY 2013 10 23

131022HCC1048

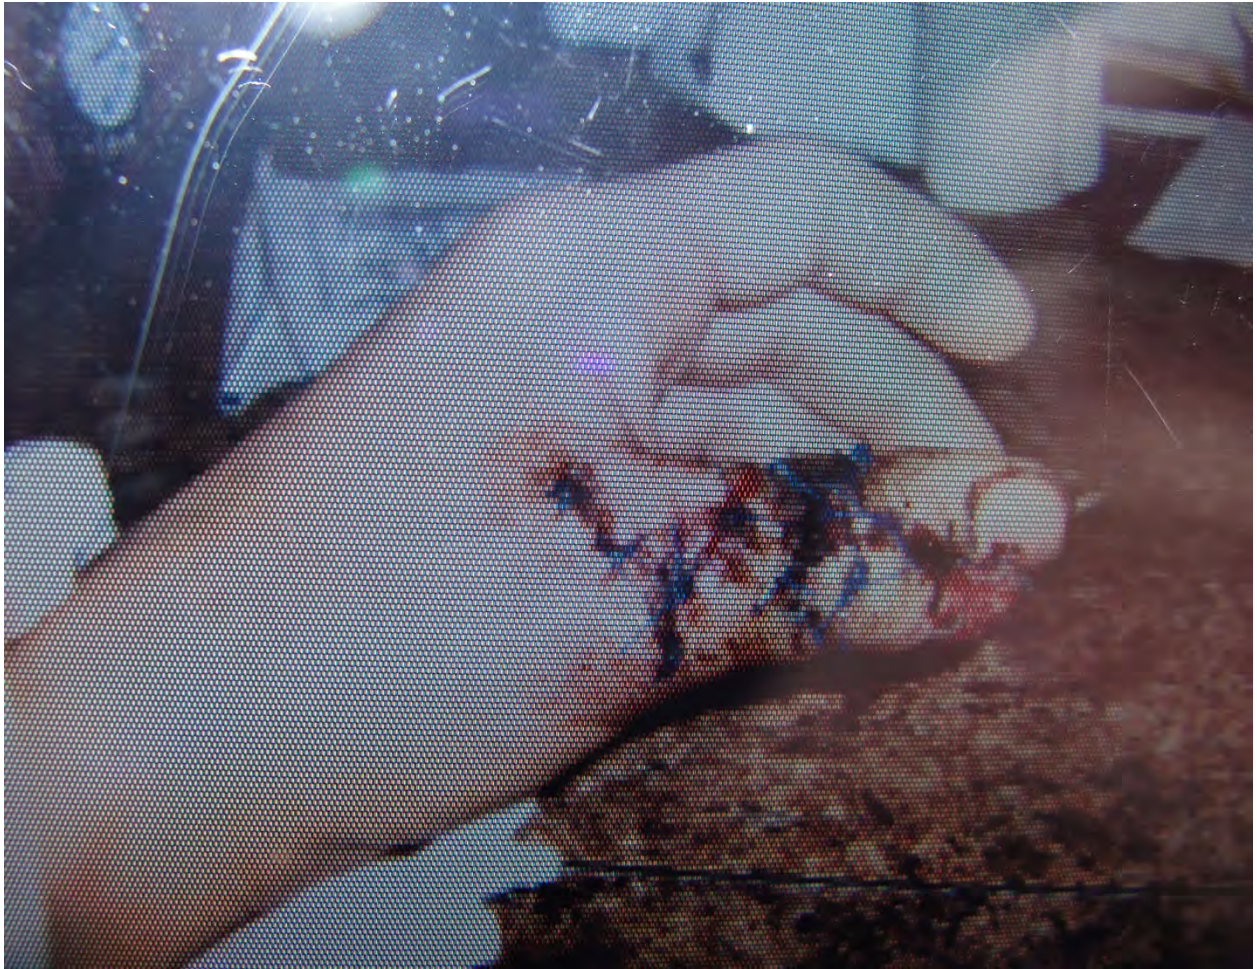
131022HCC1048 Photographs #15 depict overview of location of table saw time of incident & thumb after first surgery .

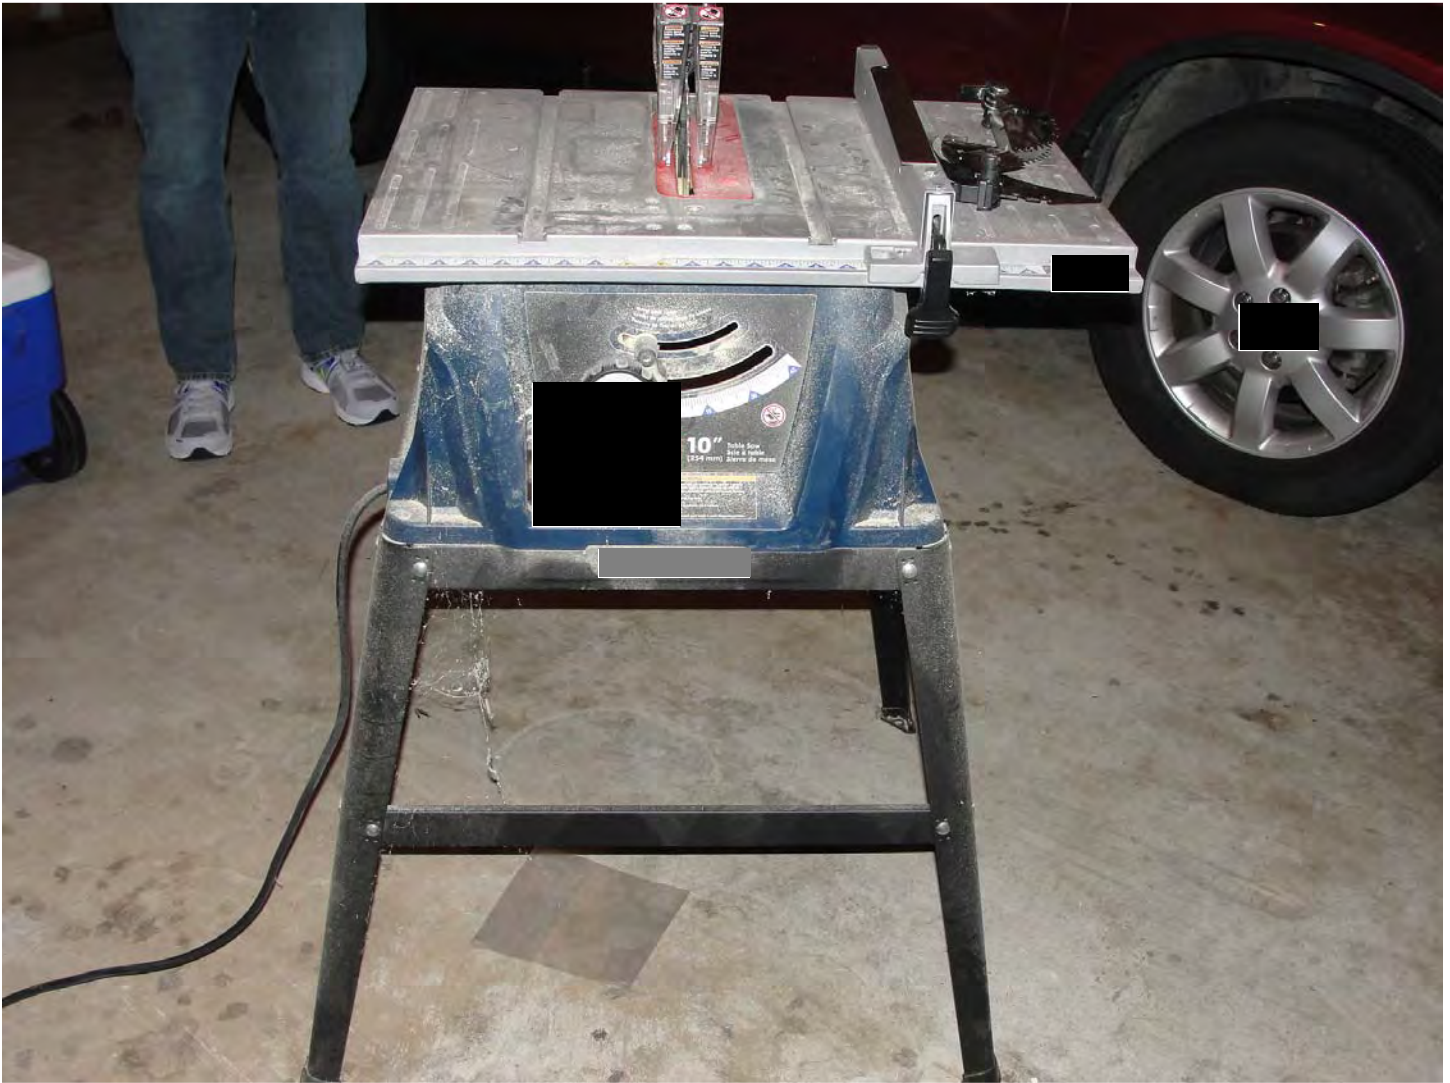
Photo 1: Overview of incident table saw with exemplar modular blade guard installed

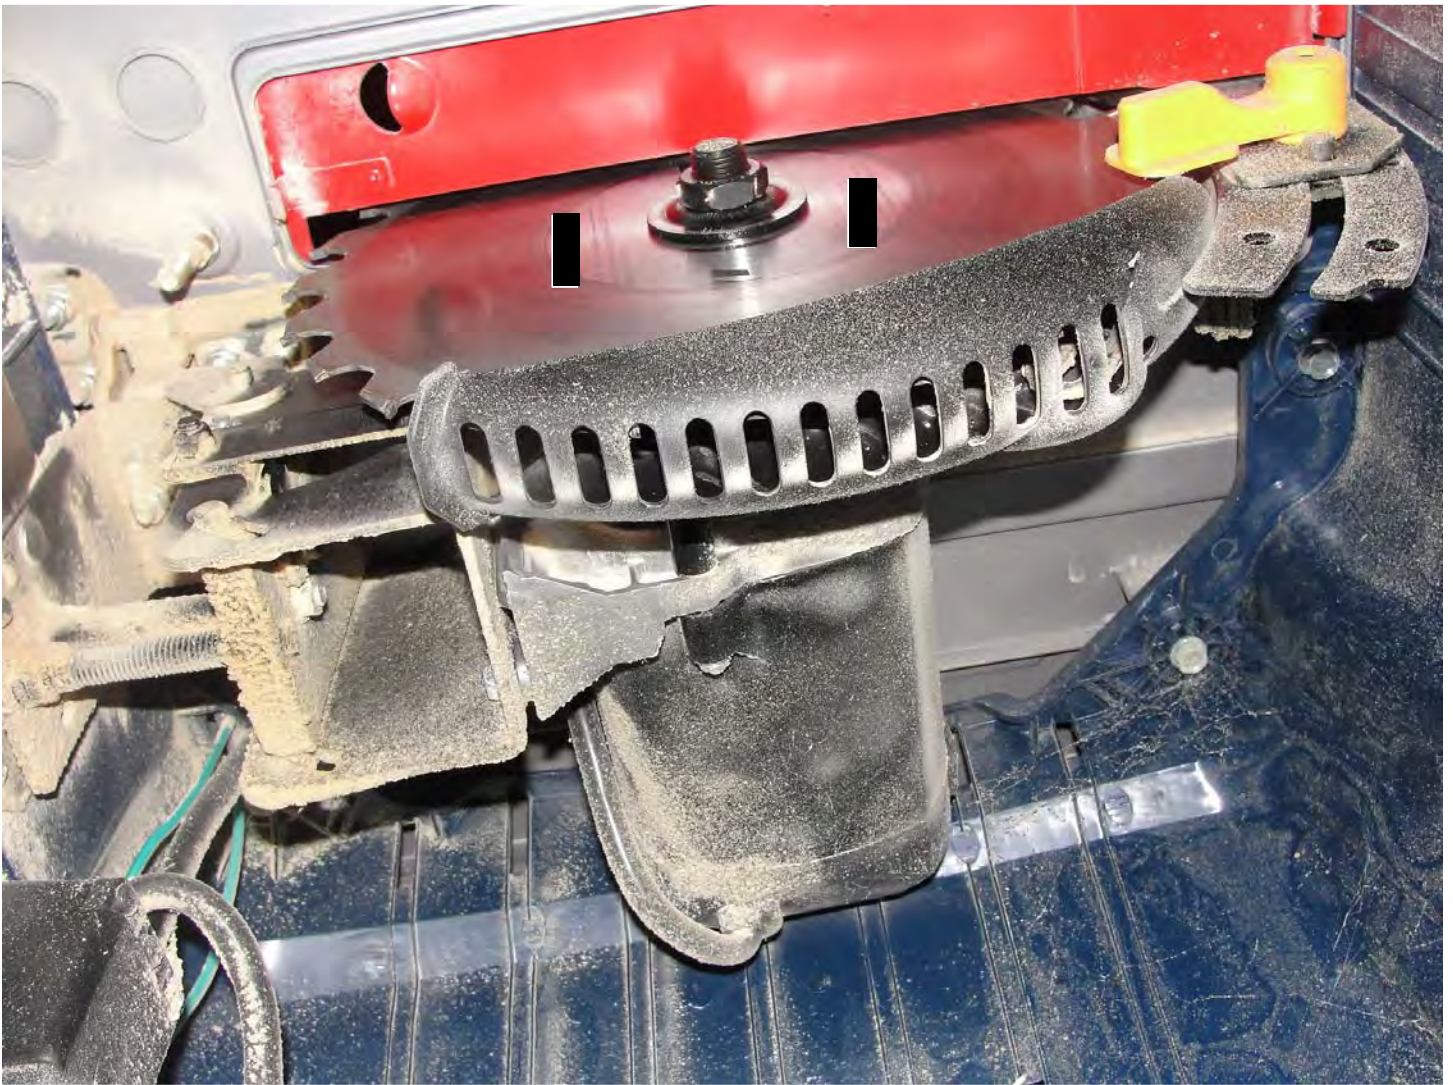
Photo 13: Underside of incident table saw

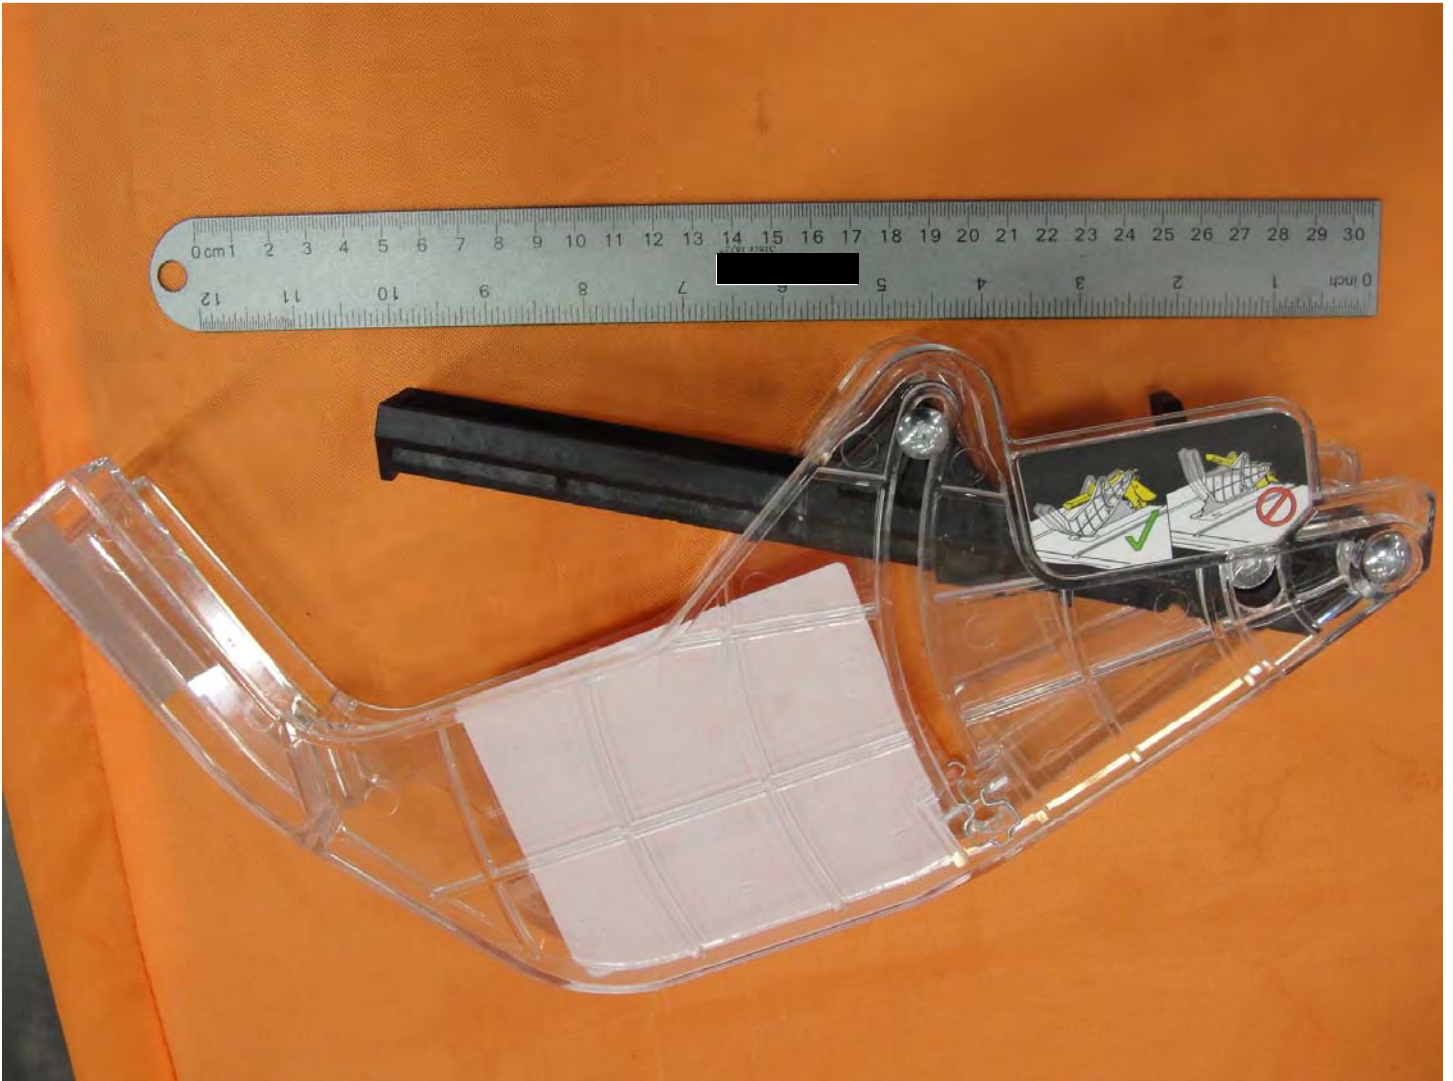
Photo 18: Overview of incident unit modular blade guard
